ADVANCED MASTERS IN STRUCTURAL ANALYSIS
OF MONUMENTS AND HISTORICAL CONSTRUCTIONS

Master's Thesis

INVENTORY OF REPAIR AND STRENGTHENING METHODS TIMBER

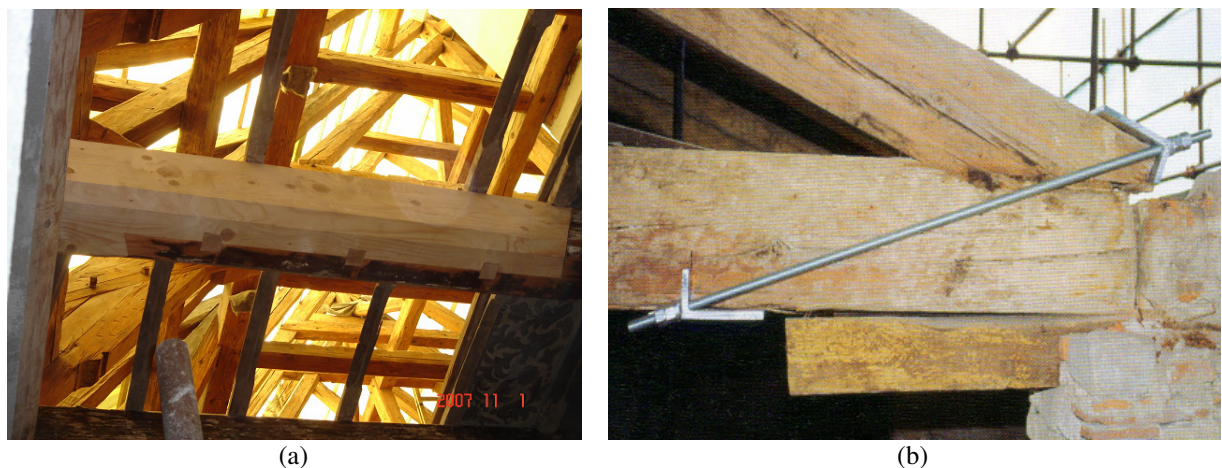
Figure 4 – (a) Prosthesisation of a damaged beam extremity by means of timber carpentry, (b) alternative to a prosthesisation in the case of a decayed support of a truss.

Both interventions shown on the figure 4 can be considered examples of good practice although different approaches were taken. While in the case of Figure 4 (a) the ideal method for prosthesisation was used (all timber intervention by means of carpentry techniques) assuring compatibility of materials, in the case of Figure 4 (b) an alternative to prosthesisation, by using a stainless steel tie, allowed the intervention to be extended to an absolute minimum.

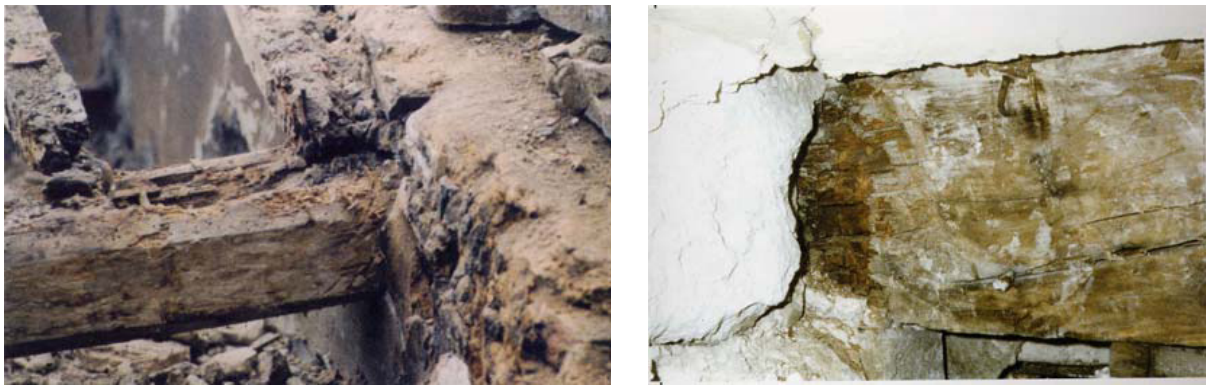
Figure 23 – Wet rot on extremities of beams, in contact with masonry.

Wet rot is a term used to cover the vast majority of fungal species responsible for timber decay. Those that can attack the cellulose but not the lignin are called brown rots. These fungi species leave the wood cross-cracked in cube-like shapes with a characteristic brown colouration. Wet rot that is capable of attacking both cellulose and lignin are called white rots and leave the affected wood fibrous and pale in colour.

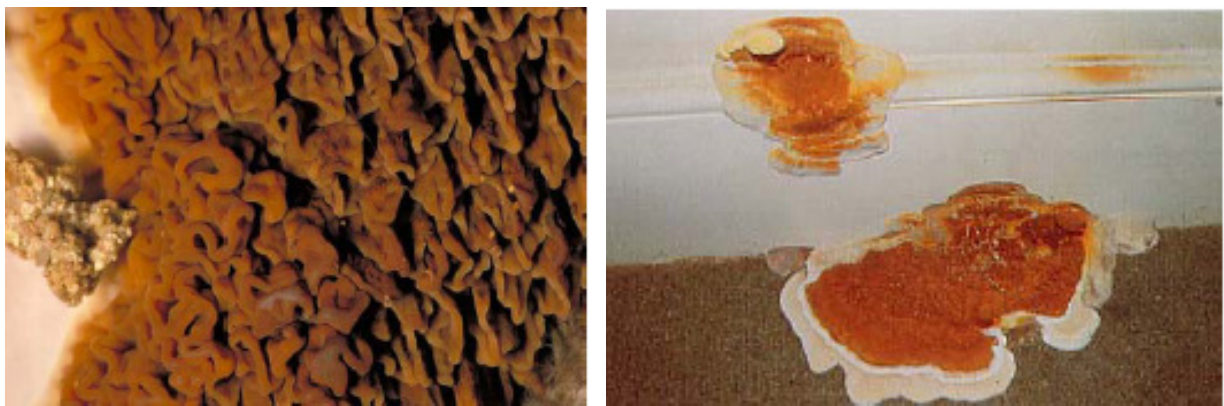
Figure 24 – Dry rot.

A particular species of brown rot, *Serpula Lacrymans*, is the only so-called dry rot fungus. The cube-like shapes on damaged wood are usually larger in size than those of other brown rots, being typically 4 to 7 cm long. A skin-like mycelium is formed, white at first and then turning grey, being easily peeled of the wood. Having a high resistance to alkaline conditions it can also form a strand mycelium that easily penetrates mortar joints in masonry walls. The growth is very fast and may reach 10mm in only one day.

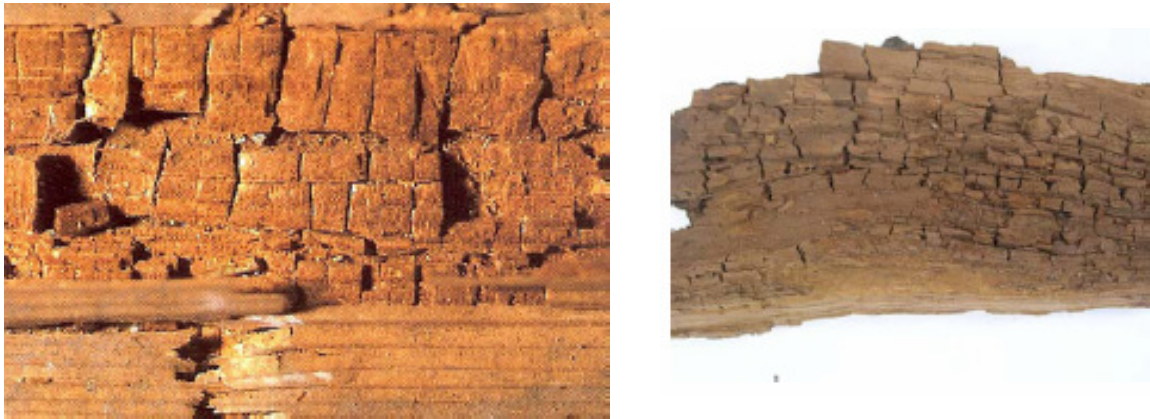
Figure 25 – Typical cube-like shapes of brown rot.

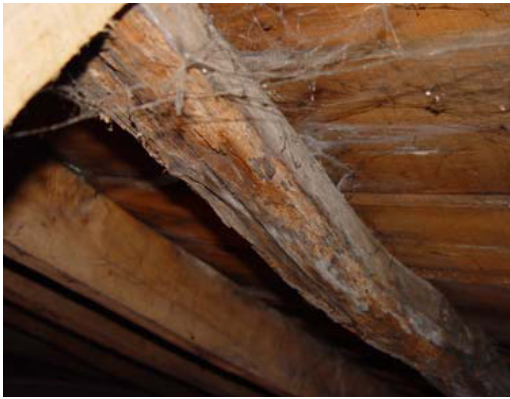
Figure 26 – Reliquary Room of Santa Cruz, Coimbra. Excessive deformation of member.

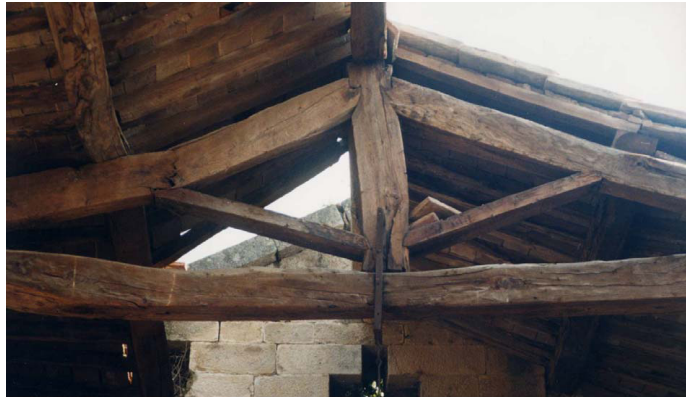
Figure 27 – Church of Mirteto, Italy. Break of the rafter of a truss caused by the instability of the strut.

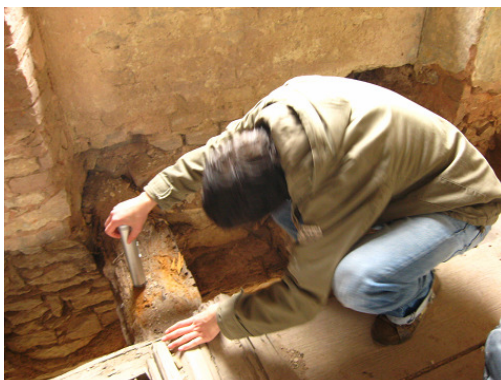
Figure 41 – Pylodin application.

The pylodin is a simple instrument that drives a pin into timber with fixed impact energy. The depth to which the pin penetrates is indicated on the instrument and is inversely proportional to the wood density. It is a simple instrument that easily allows detecting drops of wood density connected to timber decay.

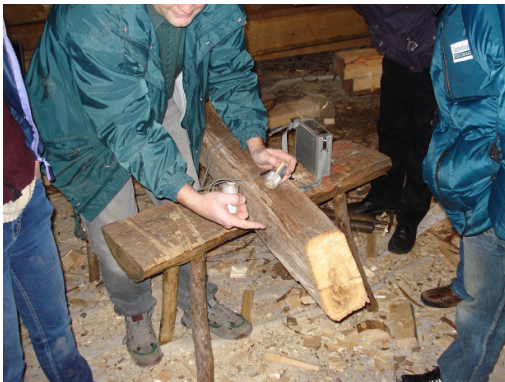
Figure 43 – Sound waves application.

The travel speed of sound or stress waves is higher on materials with higher elasticity modulus and when meeting voids in the material they contour them taking more time to reach the reception point. By applying a sound wave or stress wave in one point and by controlling the time they take to reach a reception point it is possible to detect, by comparison, sound or decayed wood and internal voids originated by biological attack.

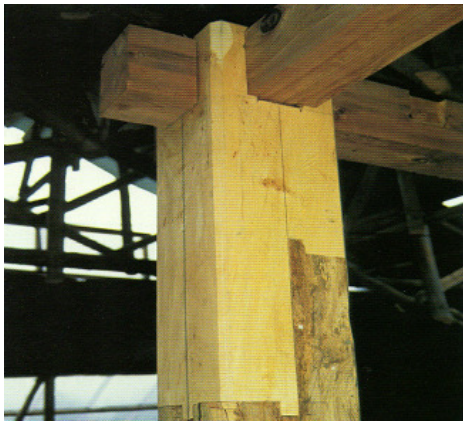
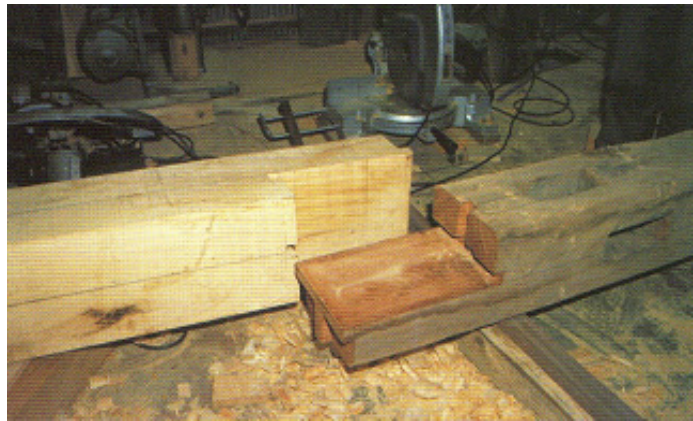
Figure 54 – Examples of timber prosthesis using traditional timber carpentry techniques (Japan).

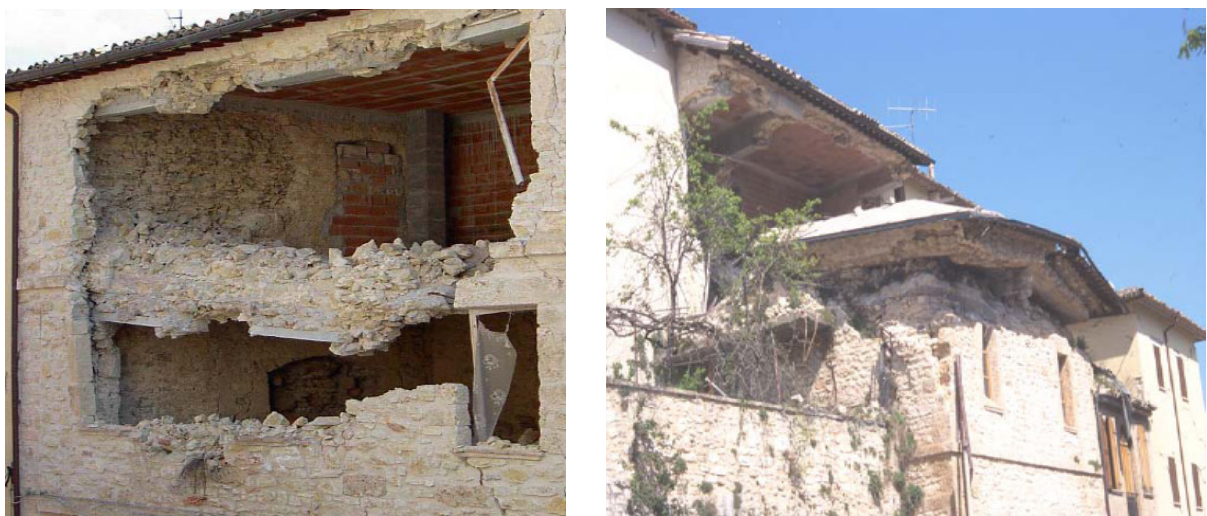
Figure 60 – Out-of-plane collapse of a masonry walls due to “hammering” of concrete floor and roof.

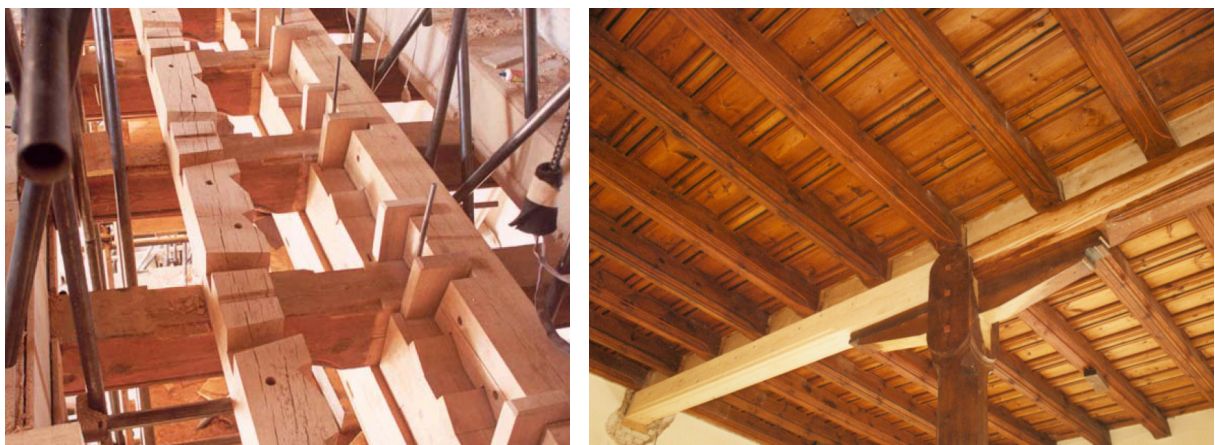
Figure 66 – .Carpentry based restoration of Karlštejn Castle timber floors.

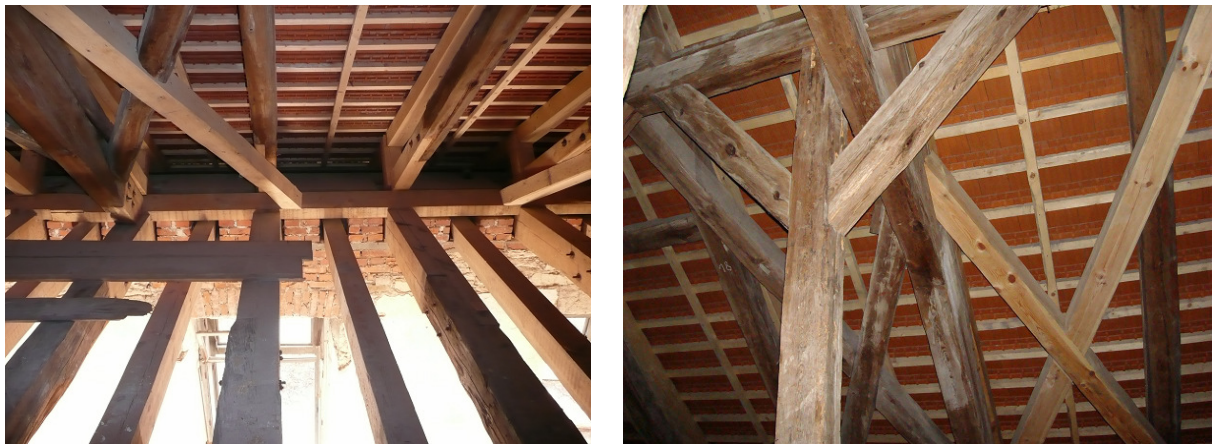
Figure 67 – Substitution of elements on Buštehrad Castle timber roof.

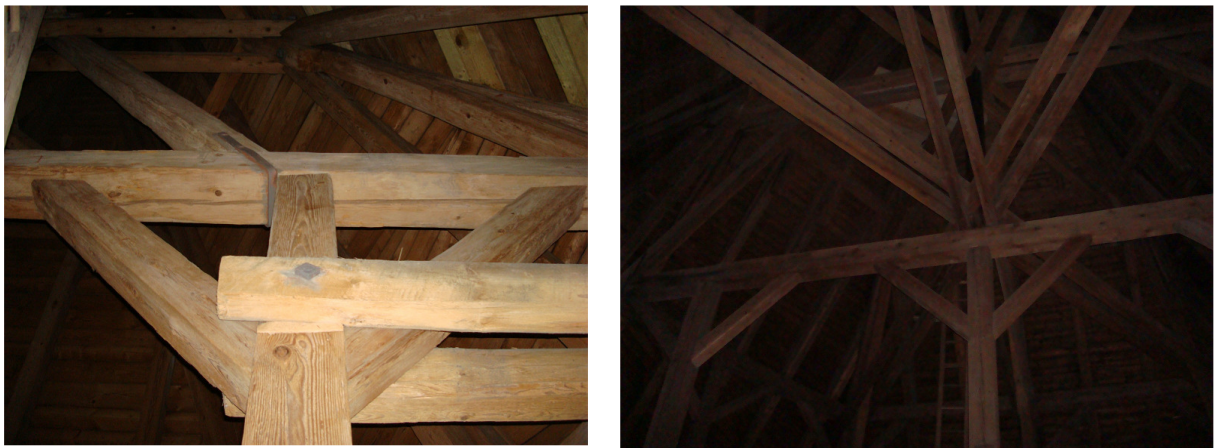
Figure 69 – Addition of timber bracing members (Kutna Hora Cathedral)

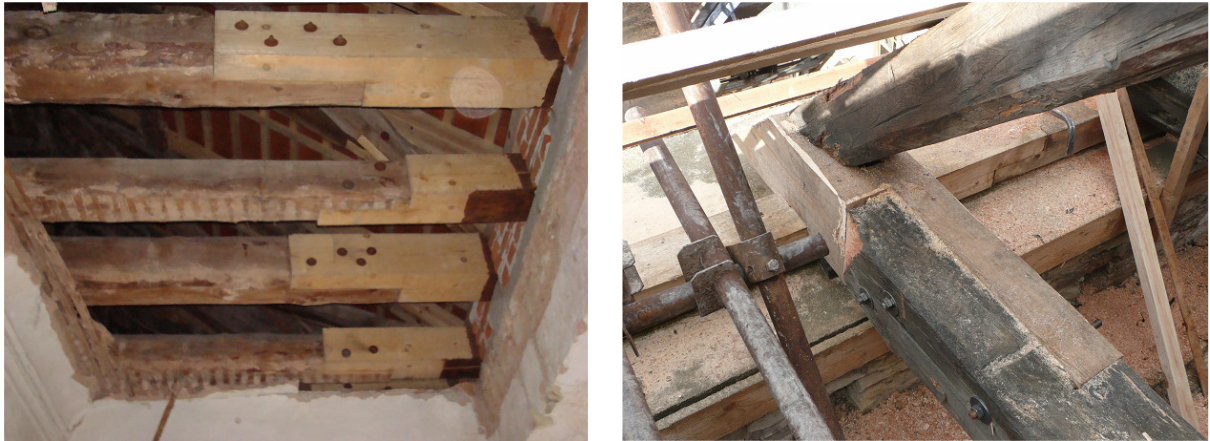
Figure 72 – Example of prosthesis with steel bolts as connectors (Buštehrad Castle).

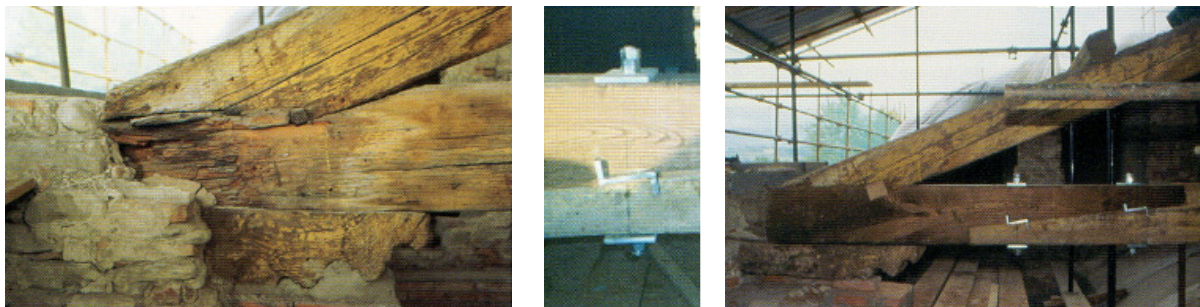
Figure 73 – Examples of prosthesisation by similar methods. In both cases the tension in the tie-beam is transmitted by a mechanism of shear parallel to the timber grain but in one case the mechanism is achieved by steel plates (a) and in the other is obtained by carpentry detail (b).

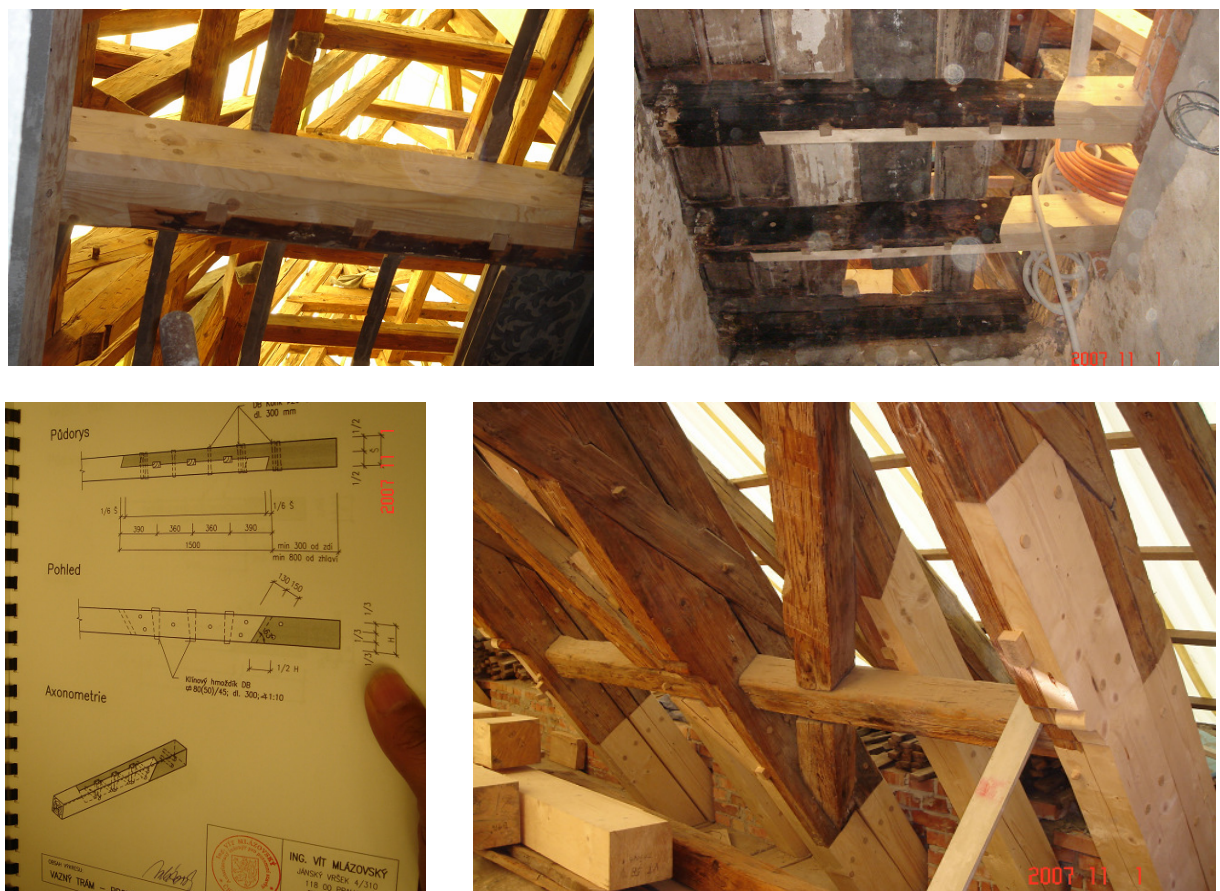
Figure 74 – Prosthesisation with all timber connections and modern carpentry techniques. “Butterfly” dowels joining old floor joists with new strengthening flange beams (Building in Prague).

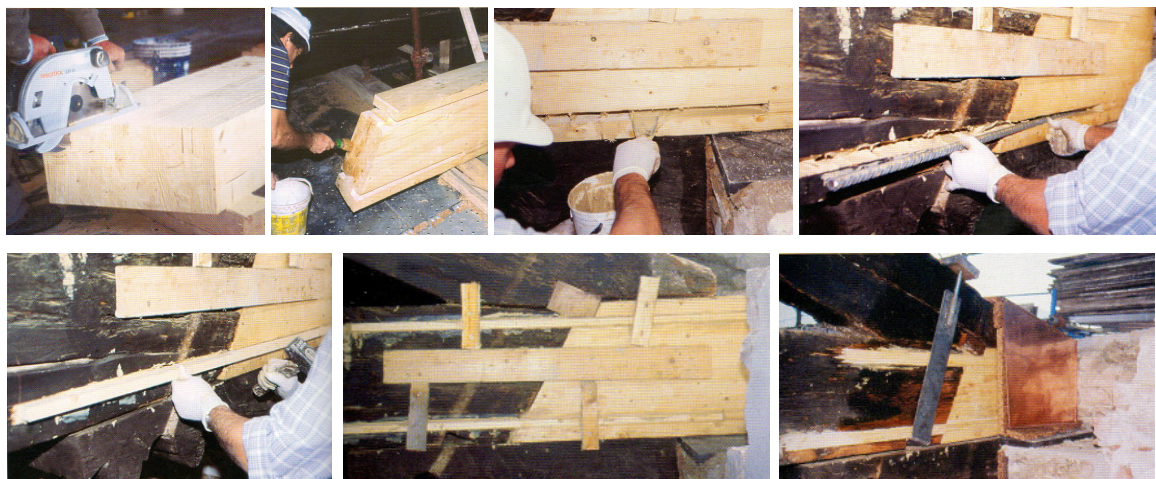
Figure 80 – Sequence of execution of a prosthesis using steel bonded bars to achieve structural continuity.

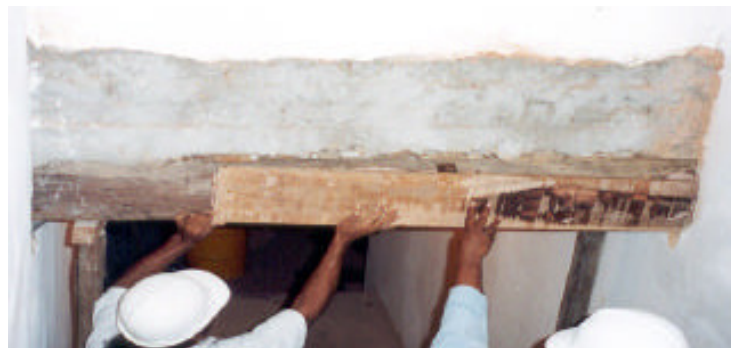
Figure 81 – Sealing.

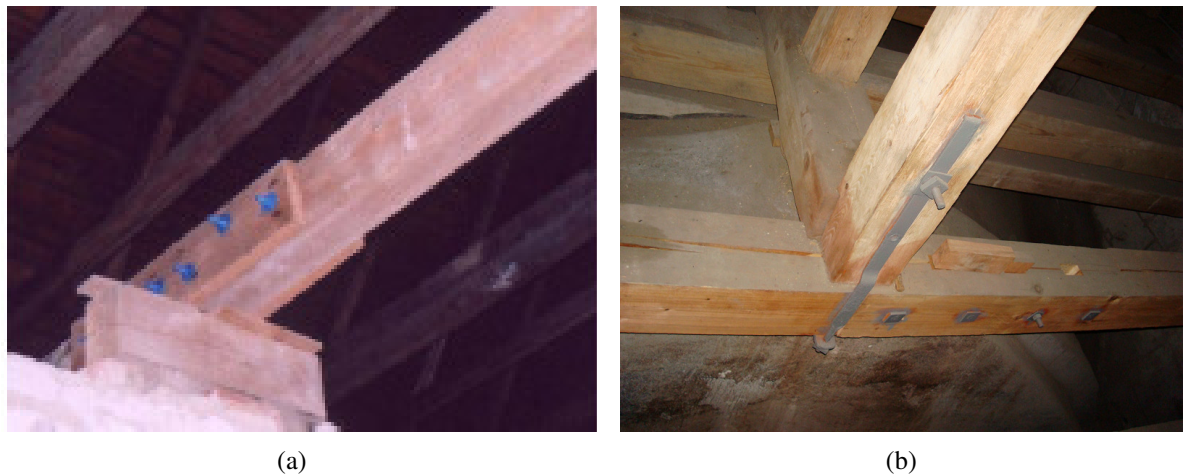
Figure 83 – Example of application of traditional techniques on the repair of cracks. (a) *Empalme*, (b) Sticking of crack with steel bolts.

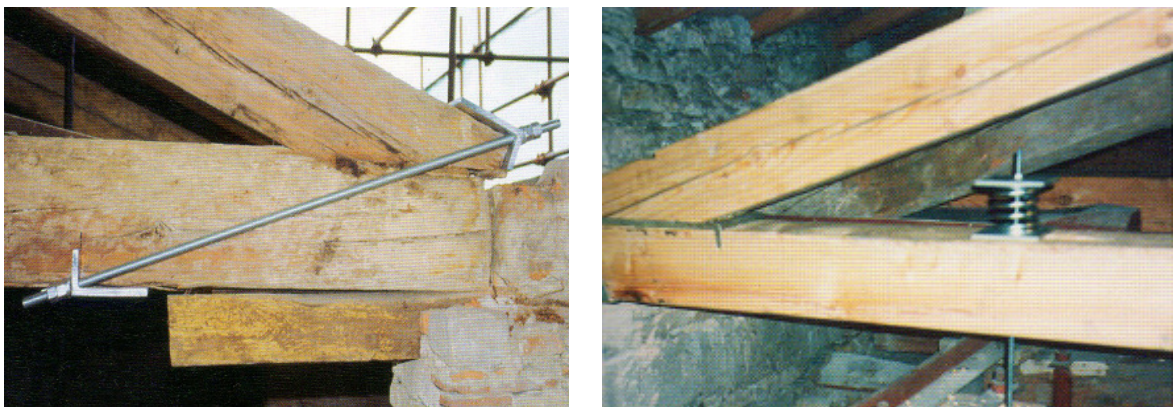
Figure 87 – Repair of connections by moving the location where the tie-beam receives the rafter horizontal thrust.

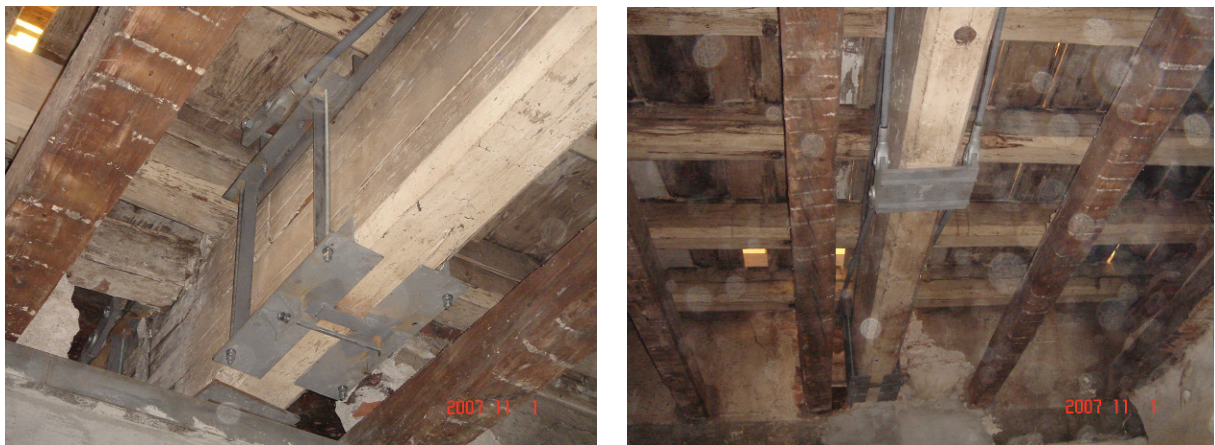
Figure 101 – Post-stressing of a beam.

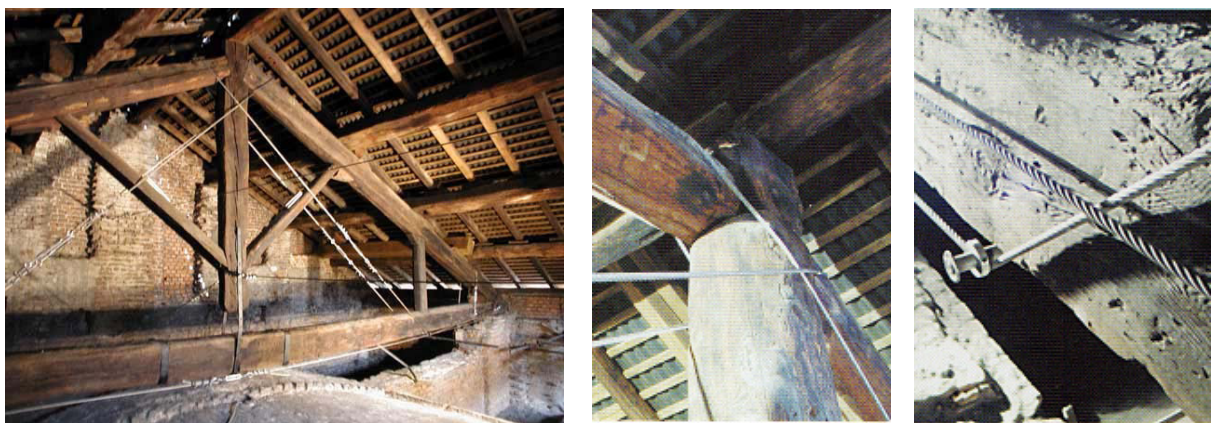
Figure 102 – Scheme and details of an intervention using post-tensioned steel cables and the addition of a timber member, giving the rafters an extra support and loosening the bending on the tie-beam at the same time.
